Third Five-Year Review Report

**Arkwood, Inc. Site
Boone County
Omaha, Arkansas**

July 2011

**Prepared By
Region 6**

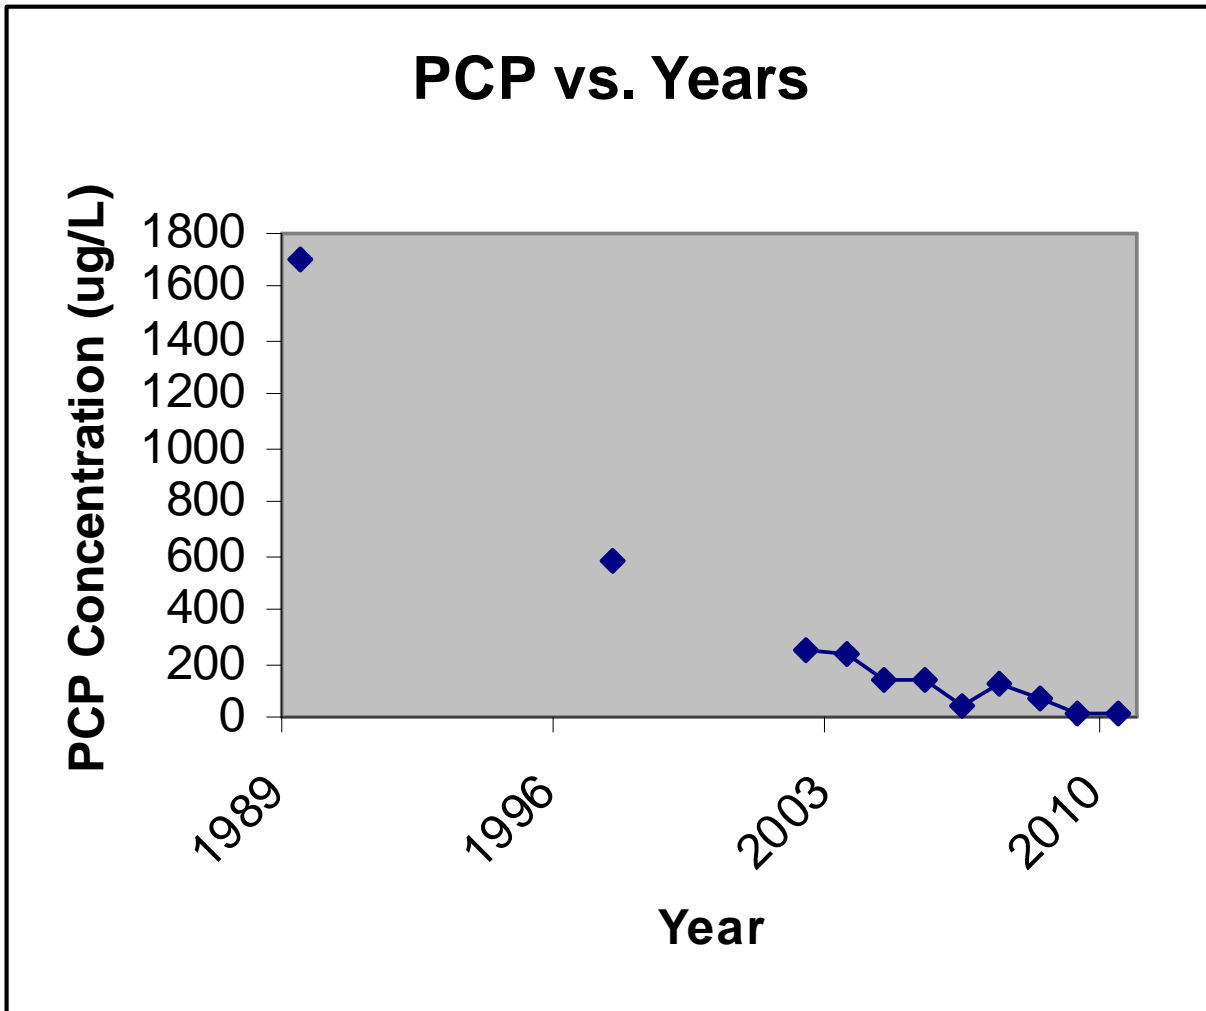
Figure 2a
New Cricket Spring
PCP Concentrations
1989-2010

1989/1990 \approx 1700
 1996/1998 \approx 581
 2002 \approx 255
 2003 \approx 237
 2004 \approx 134
 2005 \approx 132

2006 \approx 39
 2007 \approx 123
 2008 \approx 76
 2009 \approx 13
 2010 \approx 18

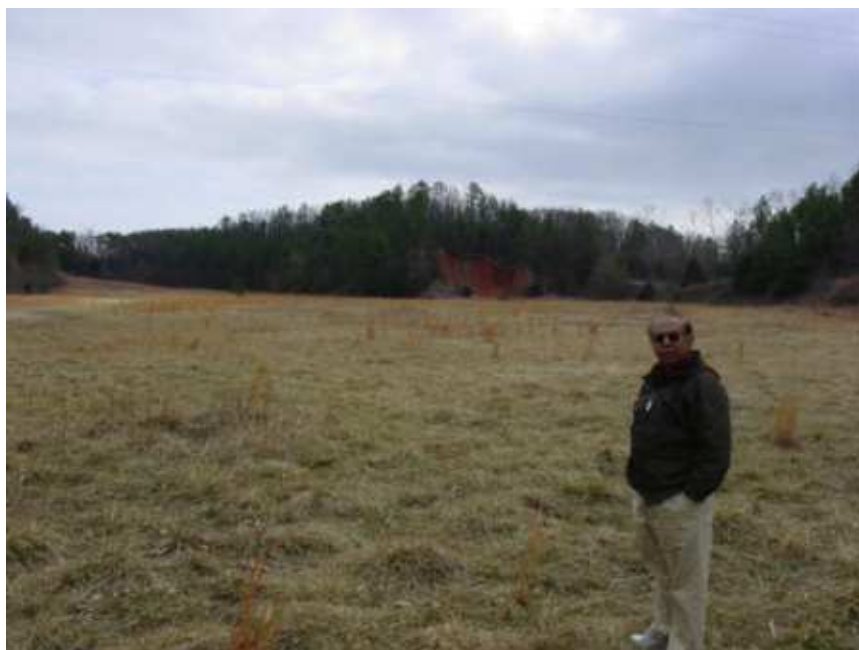
The site was found to be in good condition. There was no evidence of topsoil erosion or surface cracks and the vegetative cover is healthy. The storm water drainage ditches were free from debris and in working order. Fences and gates are maintained and provide an adequate means to restrict access. The perimeter road was in good condition and there was no evidence of unauthorized access to the site.

Figure 1-Grass cover over soil remediation area.

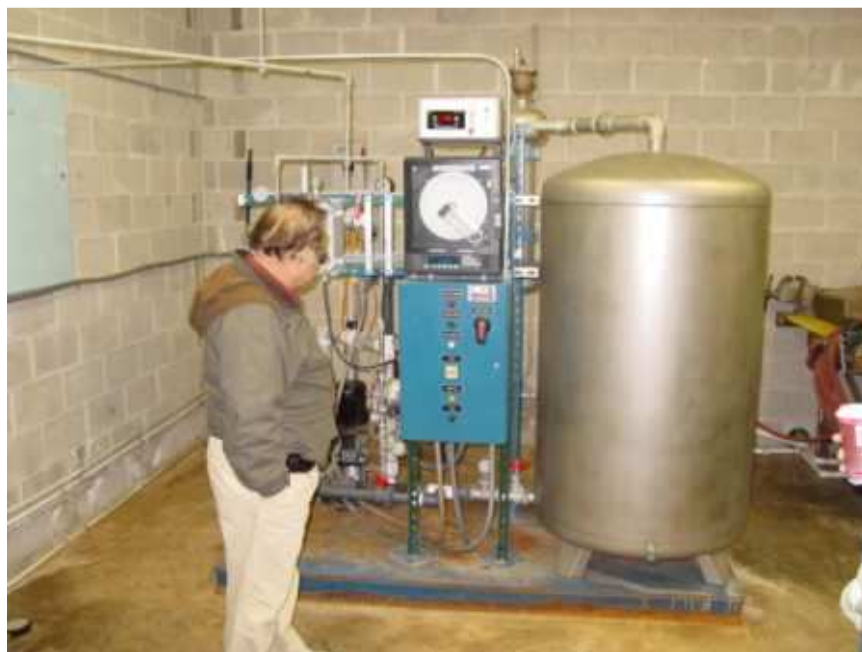
Figure 2-Injection system skid.

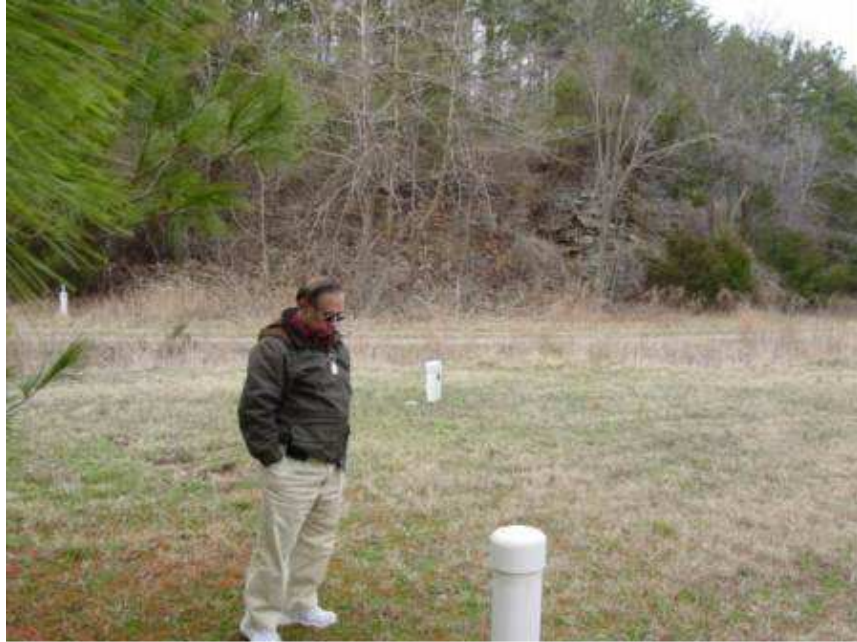
Figure 3 -Injection well field.

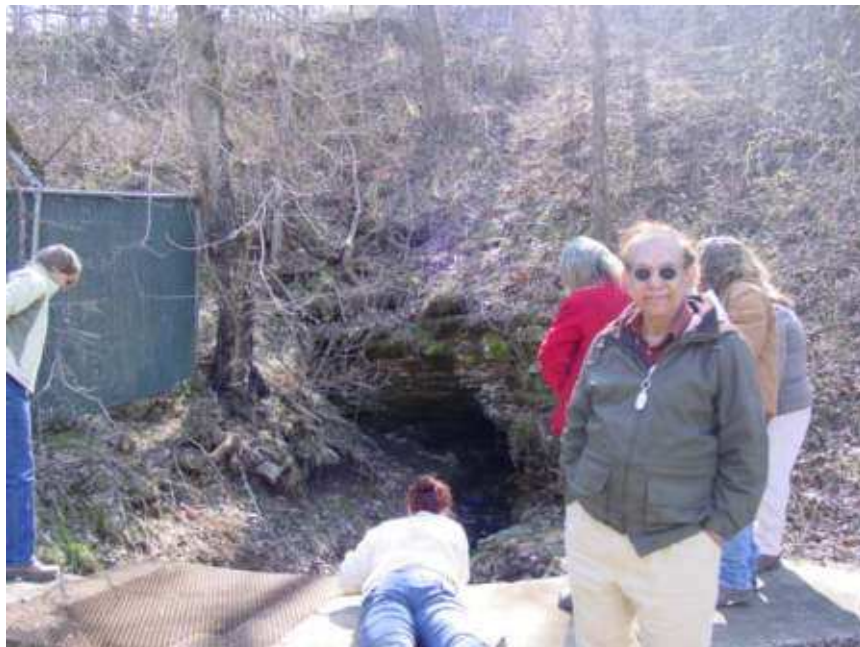
The onsite treatment building and associated equipment as well as the pump house and equipment at the mouth of New Cricket Spring were all in good condition. The equipment was well maintained and in good working order. Monthly operational samples are collected at the mouth of New Cricket Spring and at the effluent point (weir) following treatment with ozone.

Figure 4 - Mouth of New Cricket Spring.

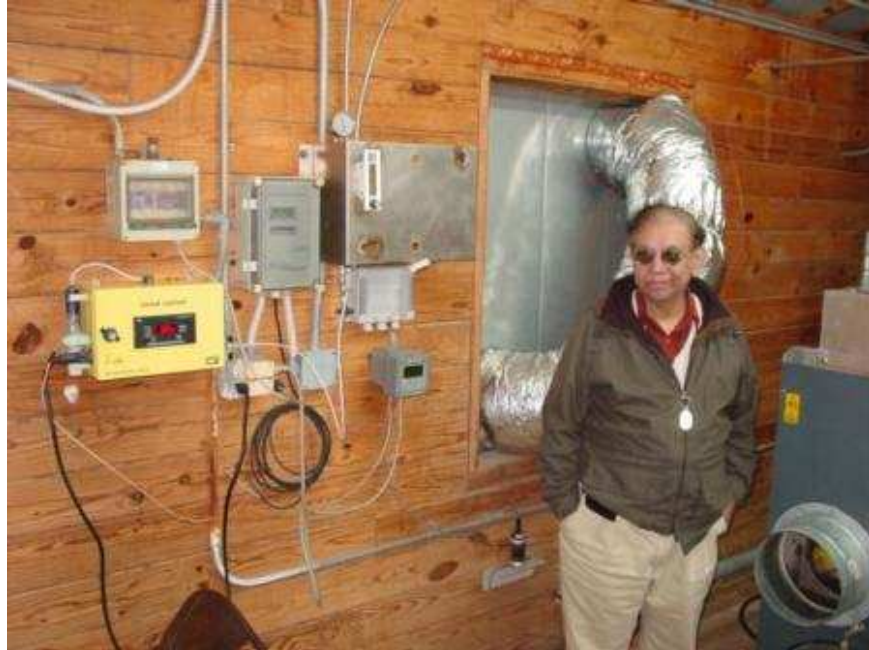
Figure 5 - Treatment system instrumentation equipment.

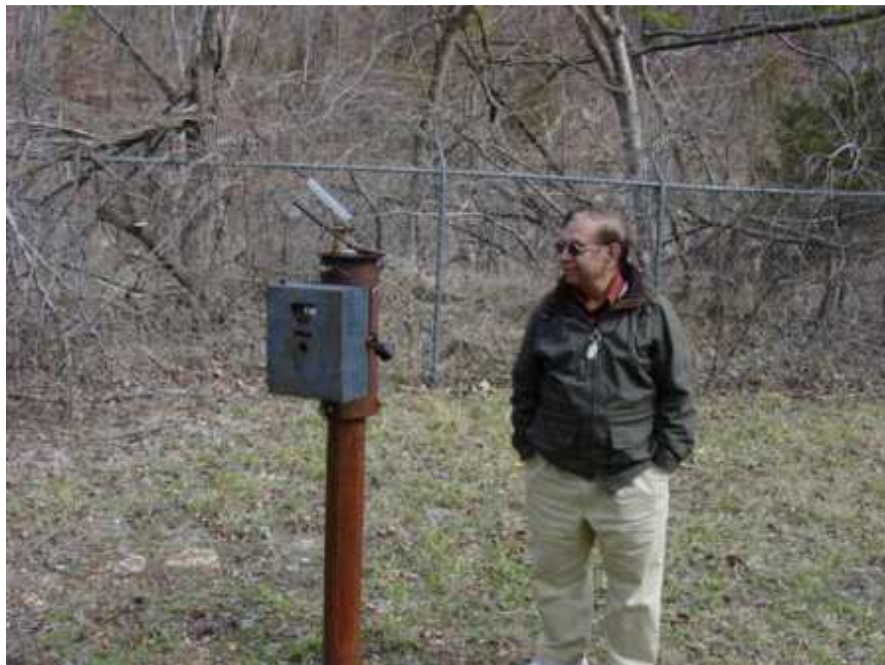
Figure 6 - Site security camera.
